Title: Product wind resistance, dynamic watertightness and impact resistance testing of a standing seam rainscreen system for Catnic Limited

Report No: N950-19-17807

**Customer:** Catnic Limited  
Pontypandy Industrial Estate,  
Caerphilly CF83 3GL

**Issue date:** 13 December 2019

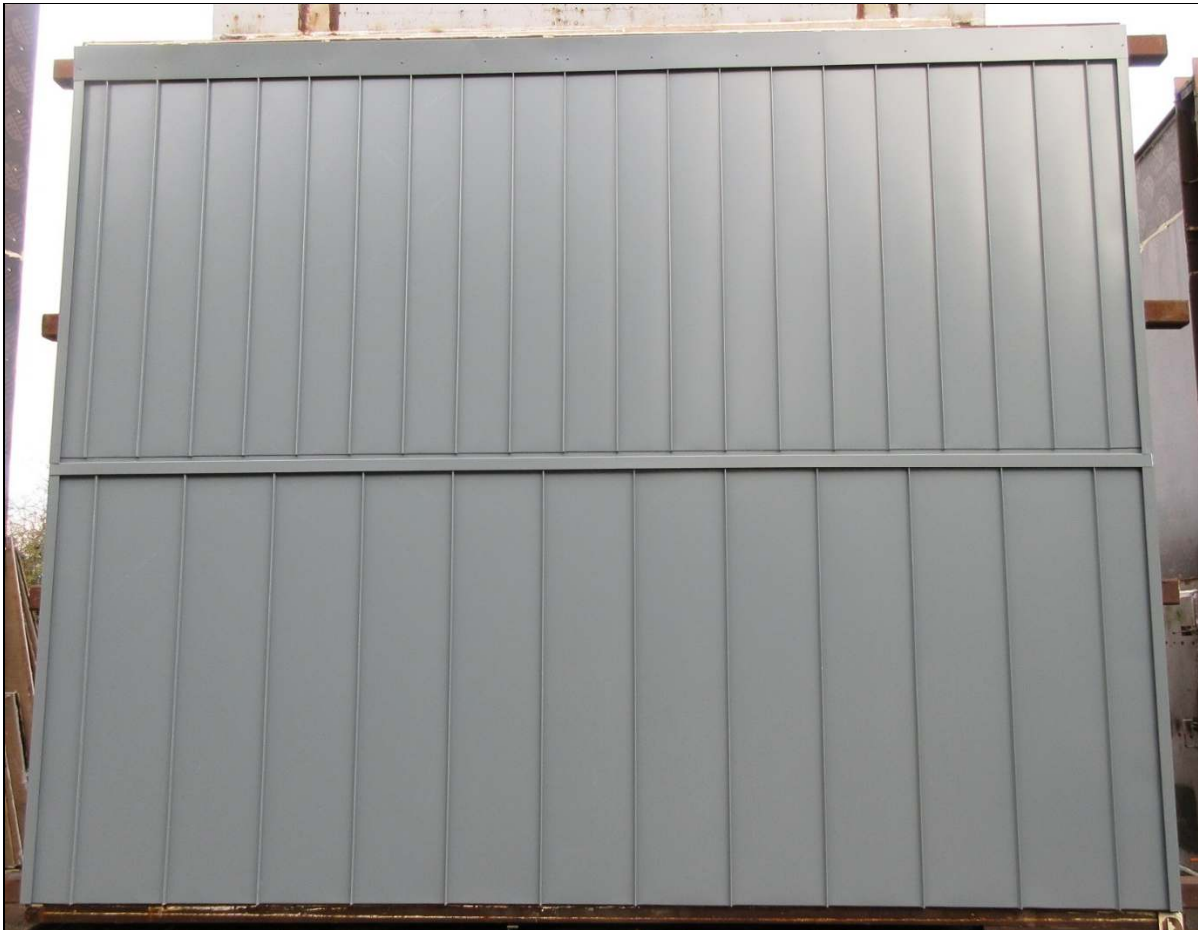
PHOTO 0915

The sample was as shown in the photo below and the drawings included as an appendix to this report.

The test sample measured 5.0 m high by 6.1m wide.

TEST SAMPLE ELEVATION

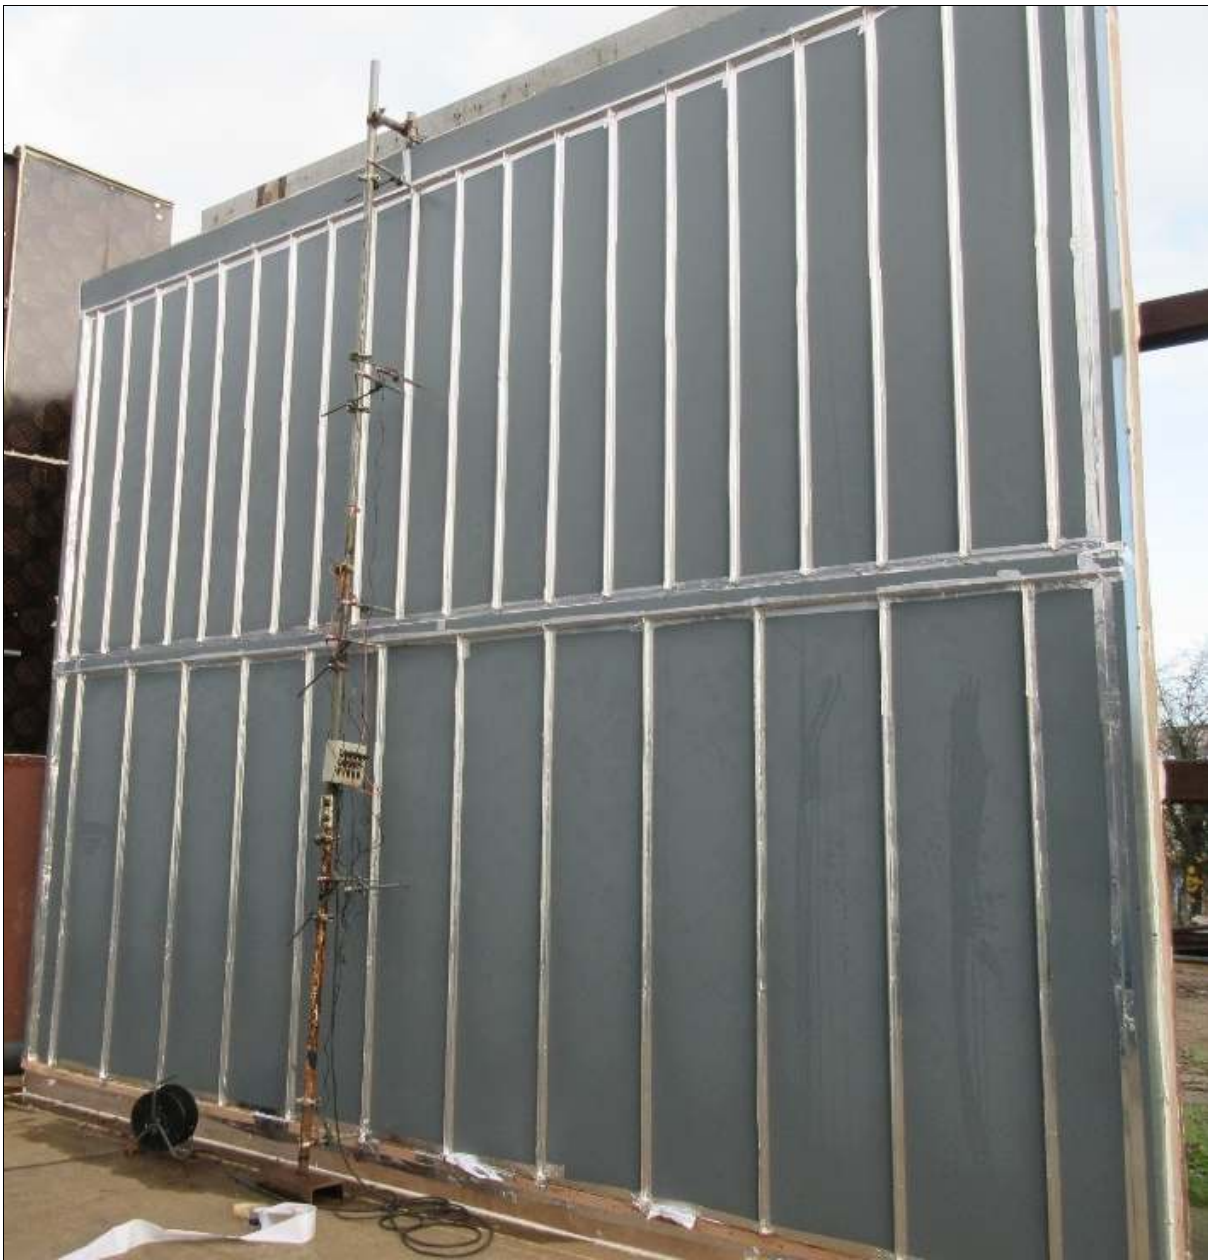
TEST SAMPLE DURING WIND RESISTANCE TESTING

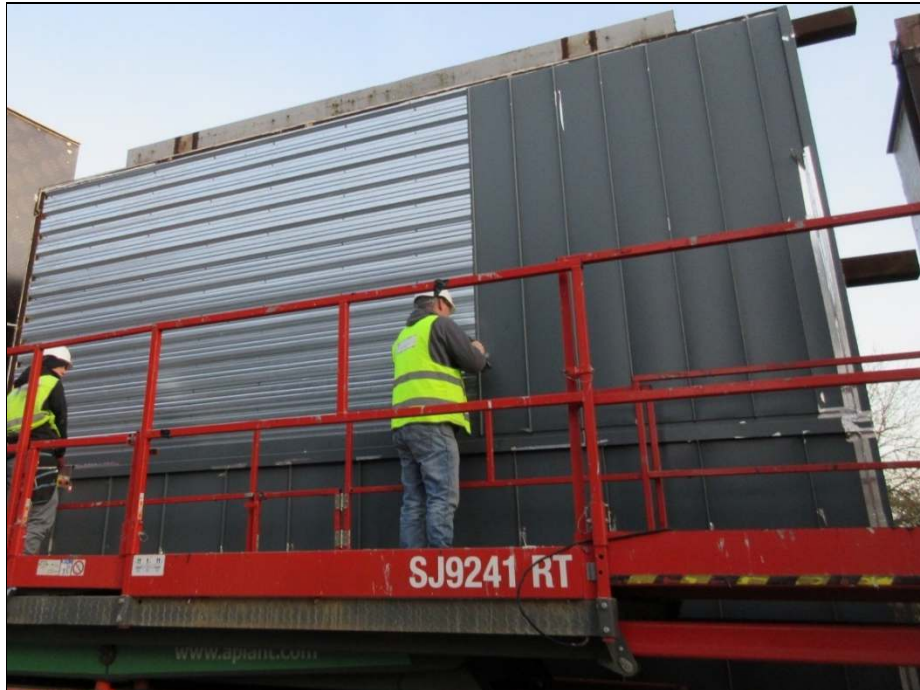
PHOTO 0905

During the dismantling of the sample no discrepancies from the drawings were found.

SAMPLE DURING DISMANTLE

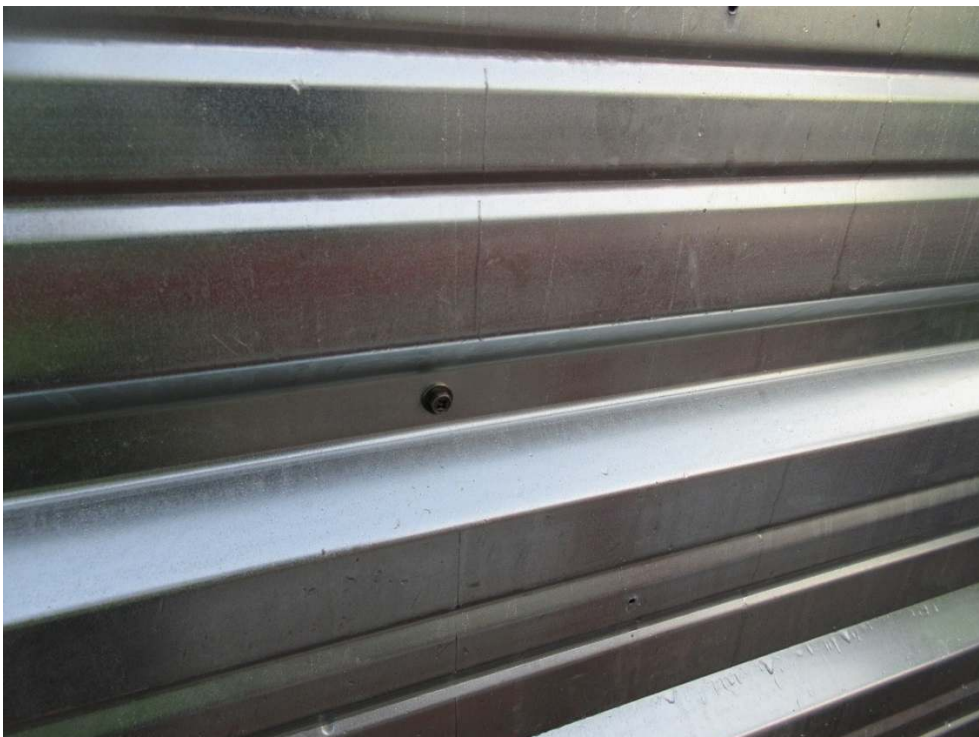
PHOTO 0906

SAMPLE DURING DISMANTLE

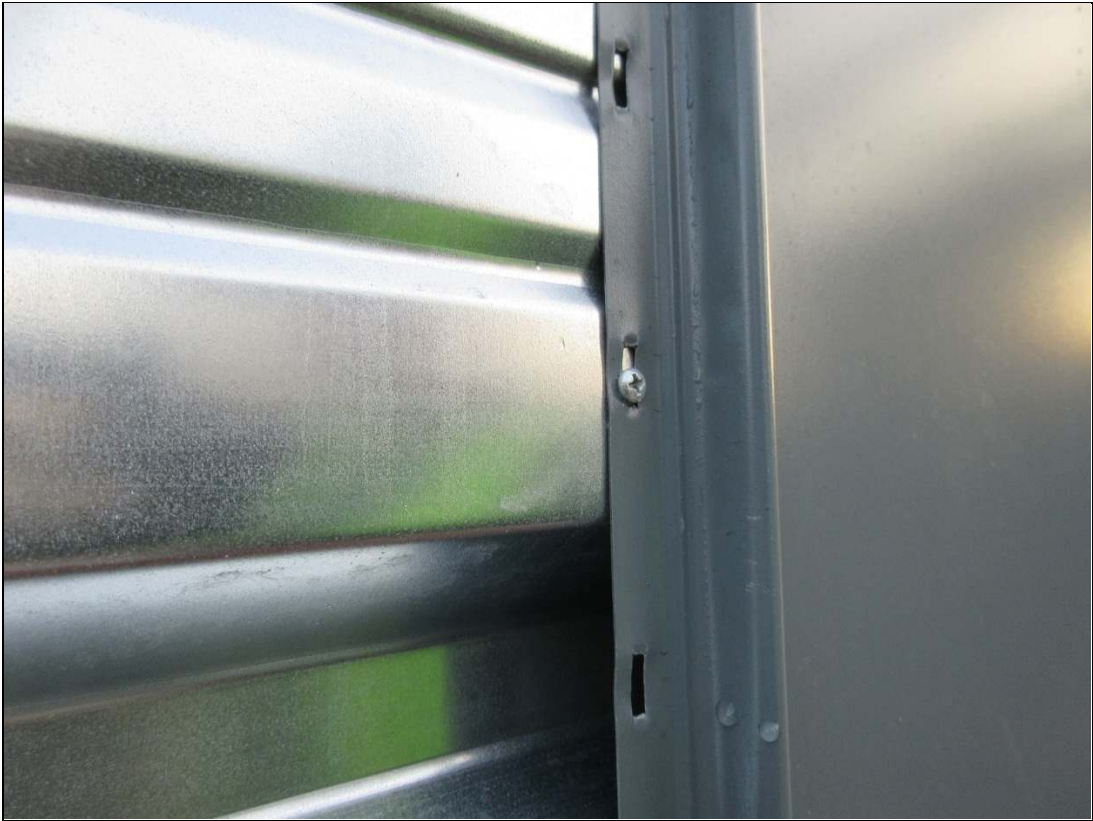
PHOTO 1005

SAMPLE DURING DISMANTLE

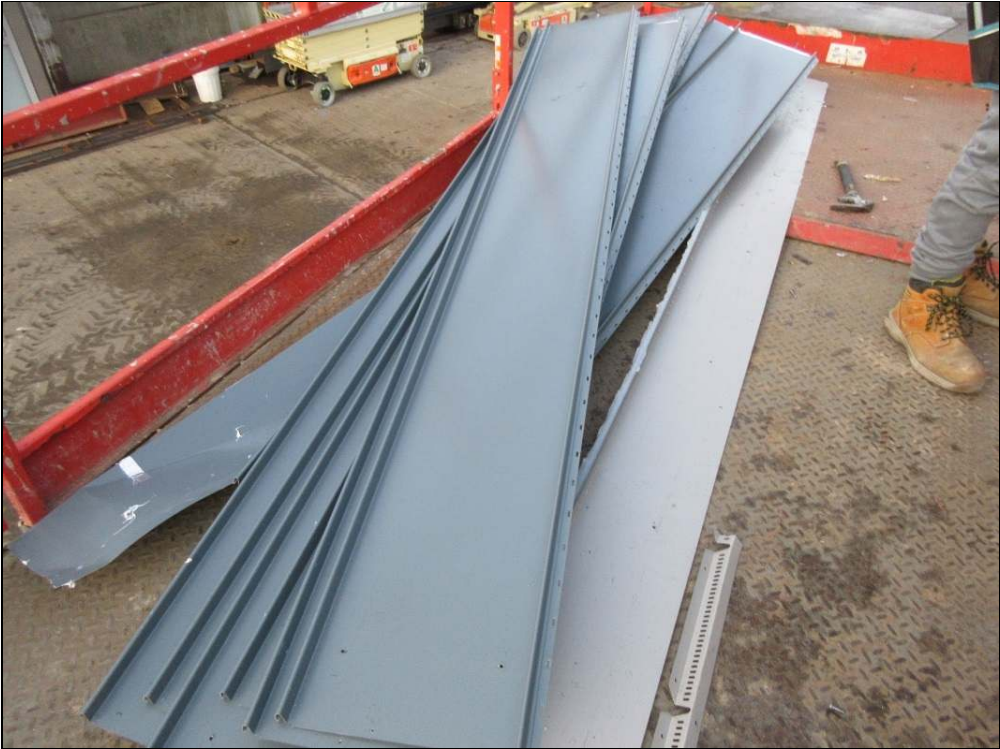
PHOTO 1007

PANELS REMOVED FROM TEST RIG

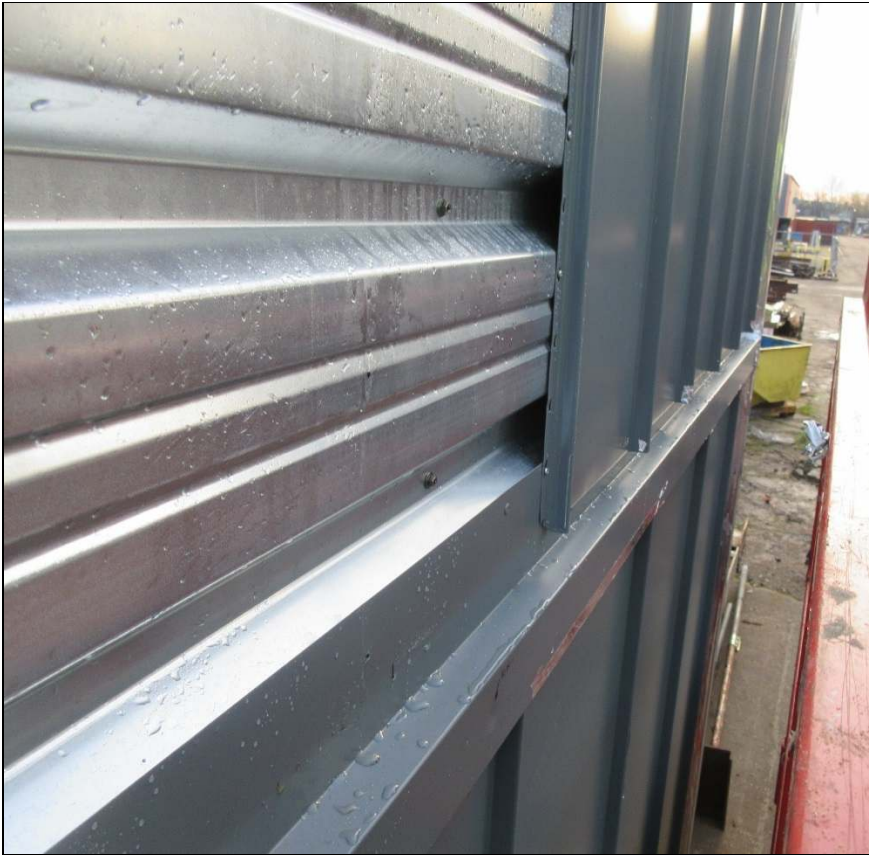
PHOTO 1010

SAMPLE DURING DISMANTLE

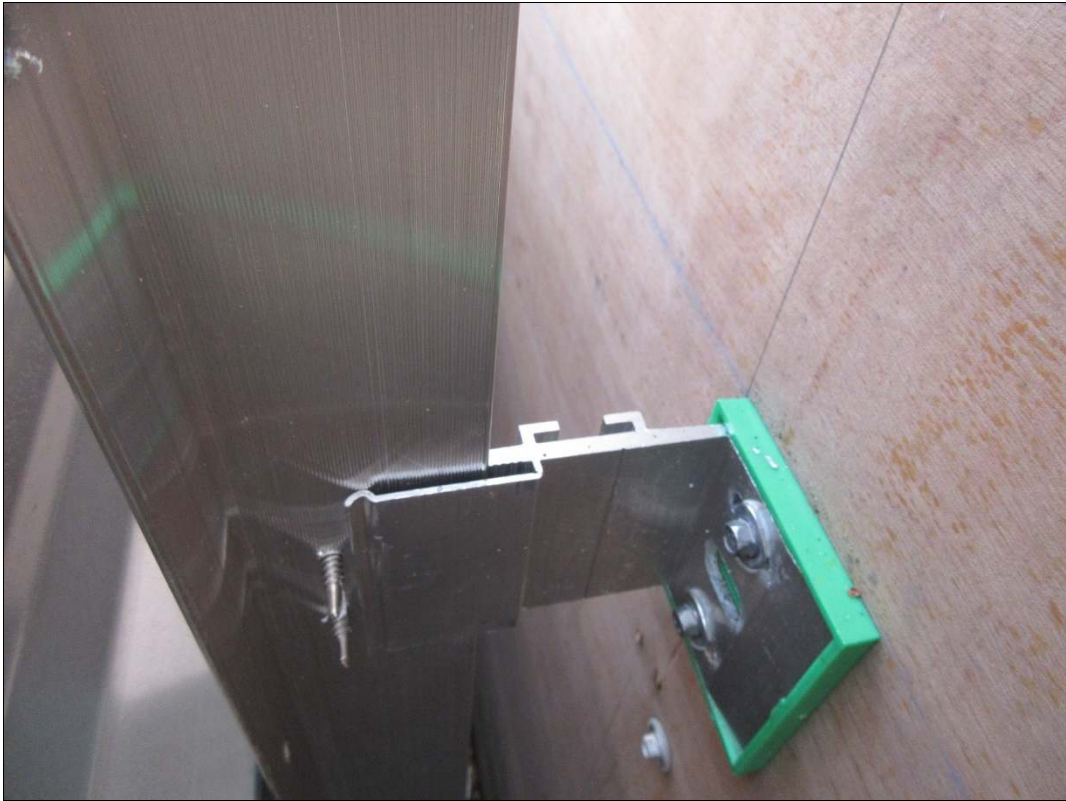
FIXING BRACKET

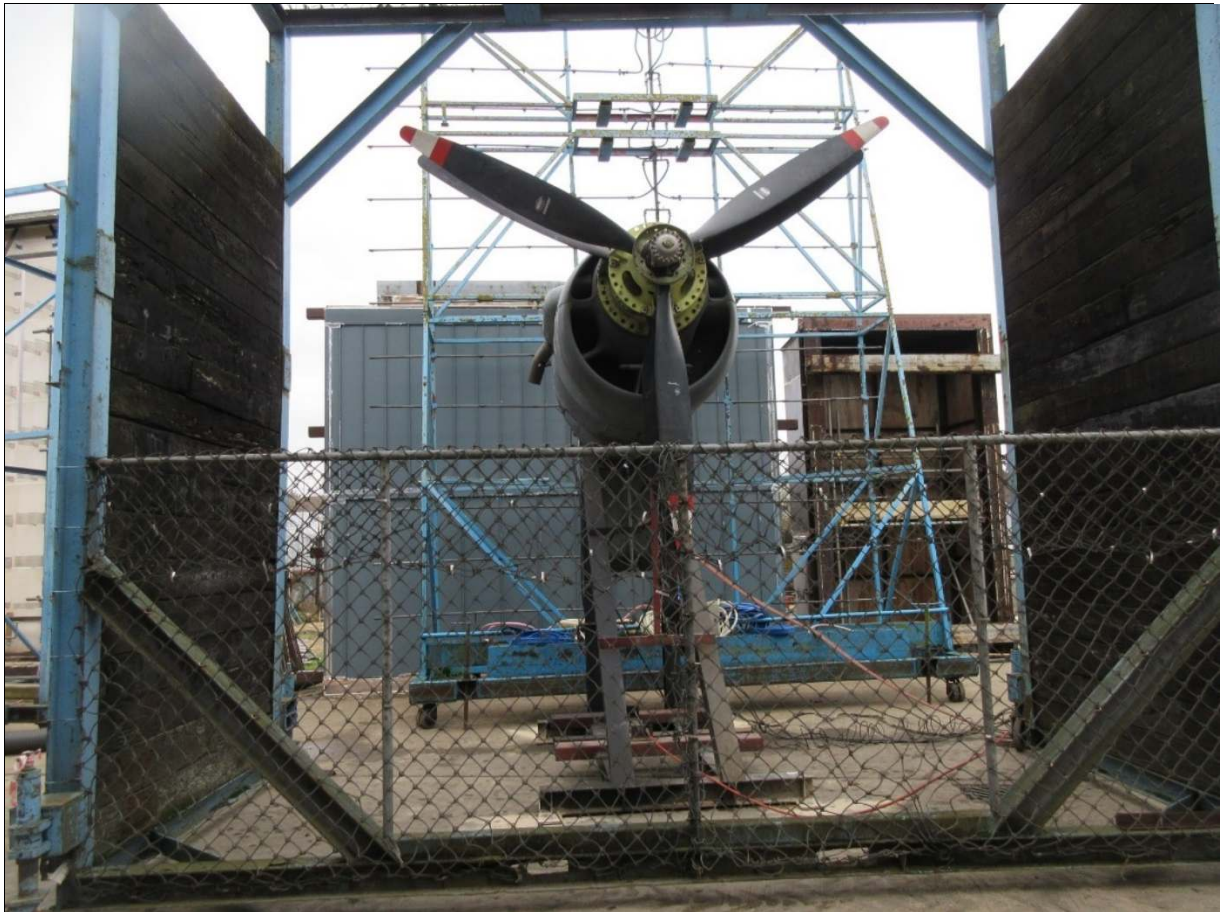
PHOTO 0983

A wind generator was mounted adjacent to the external face of the sample and used to create positive pressure differentials during dynamic testing. The wind generator comprised a piston type aero-engine fitted with 4 m diameter contra-rotating propellers.

DYNAMIC WIND GENERATOR

The aero-engine was used to subject the sample to wind of sufficient velocity to produce average deflections in the principle framing members equal to those produced by a static pressure differential of 600 pascals. These conditions were maintained for 15 minutes. Throughout the test the inside of the sample was examined for water penetration.

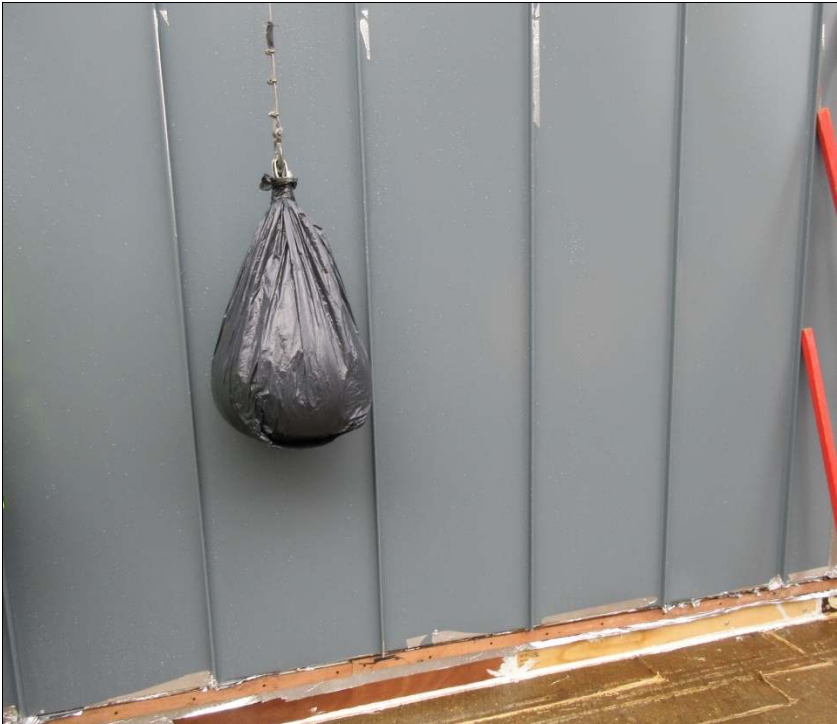
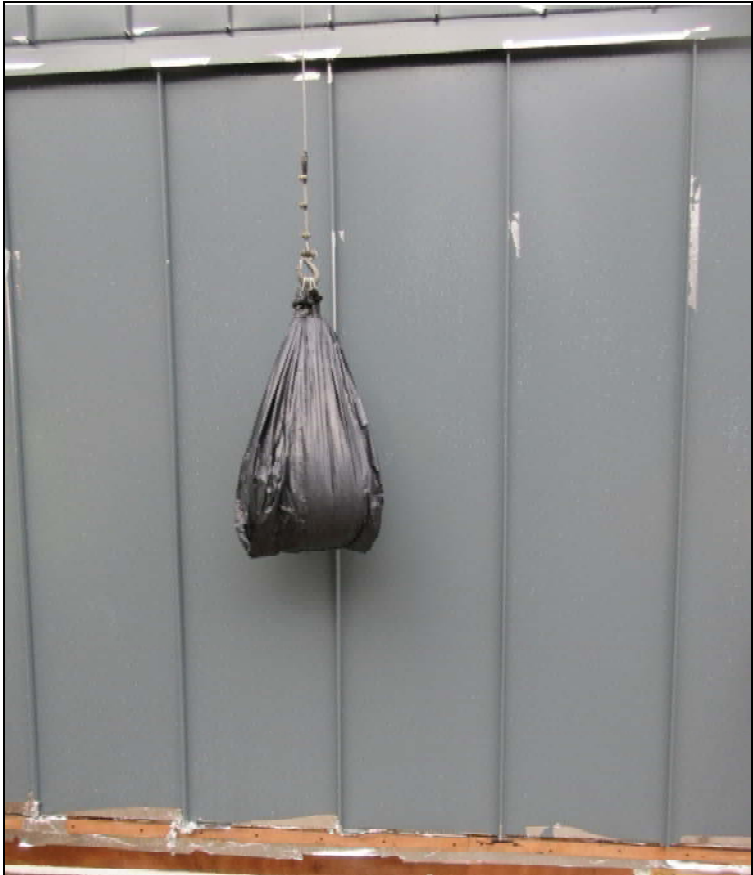
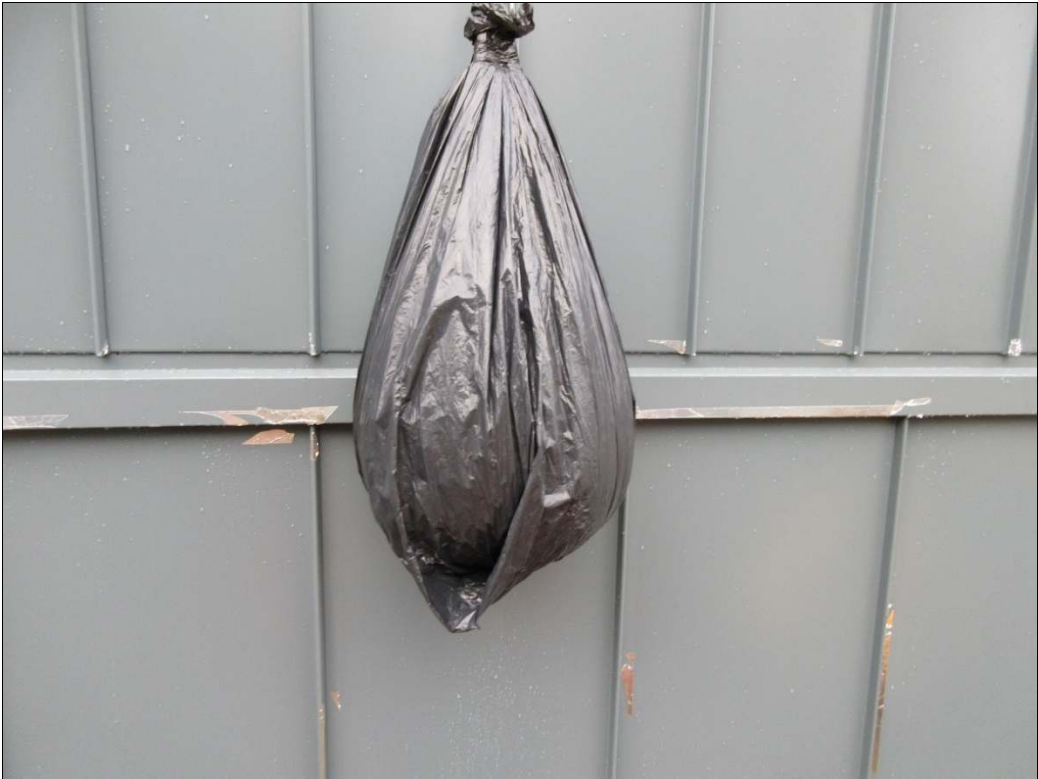
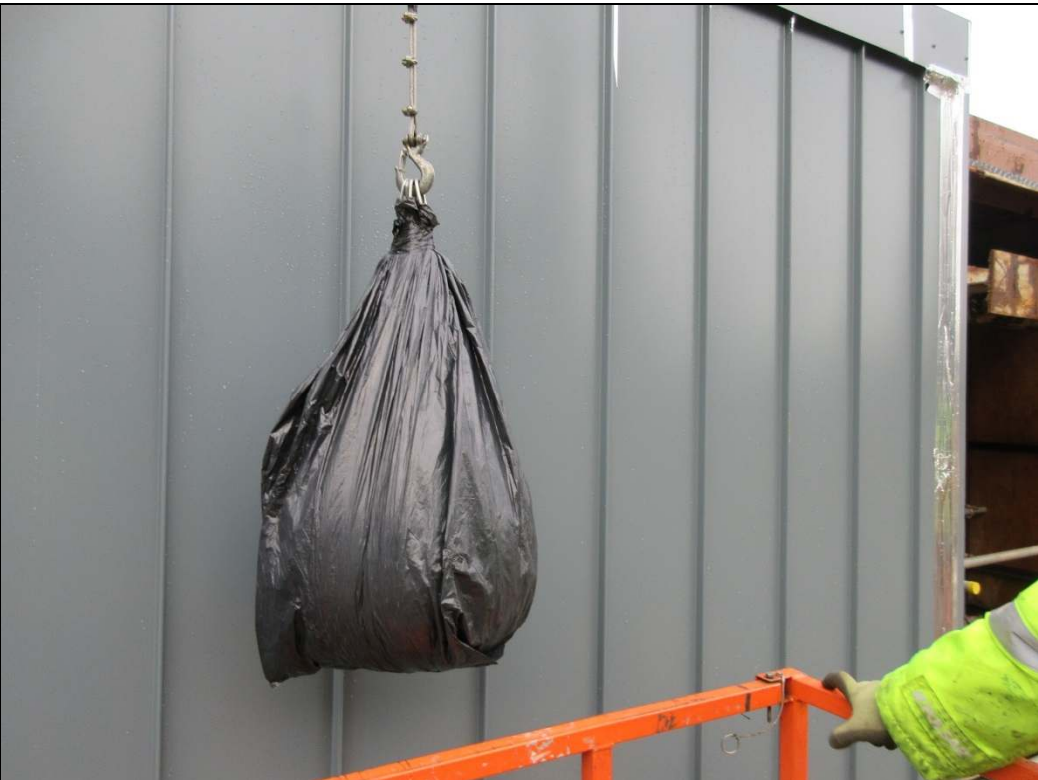
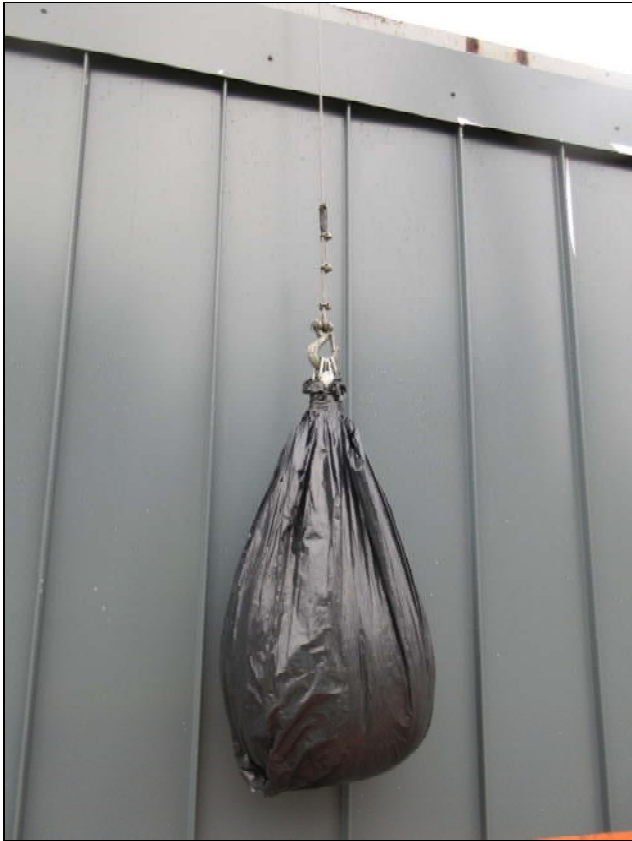
SOFT BODY IMPACT

**SOFT BODY IMPACT**

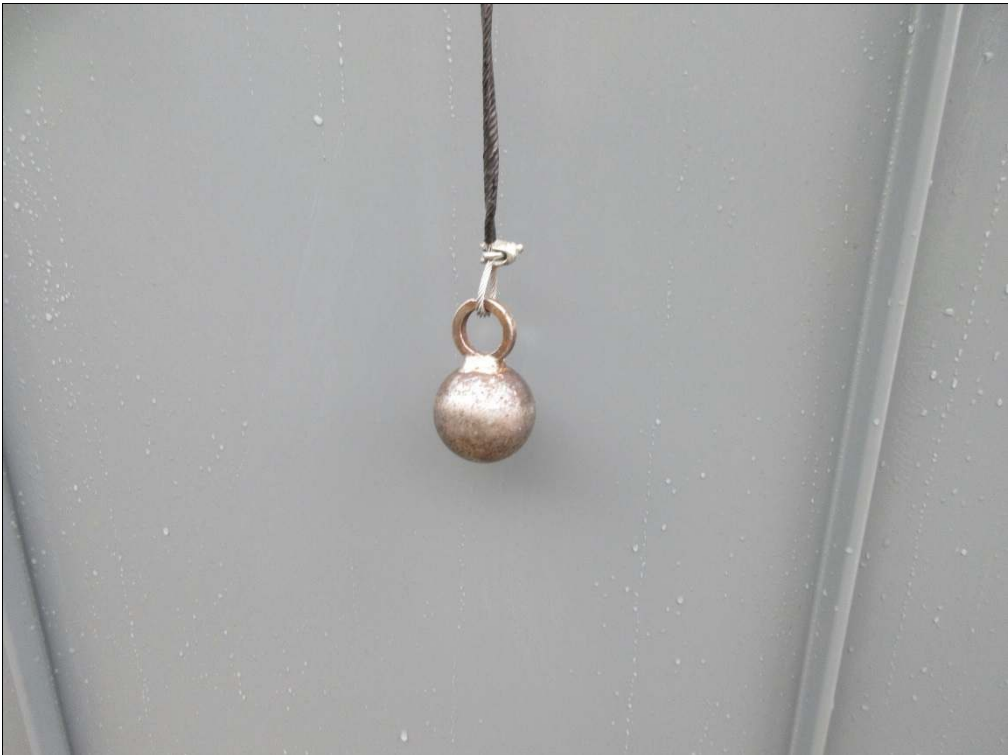
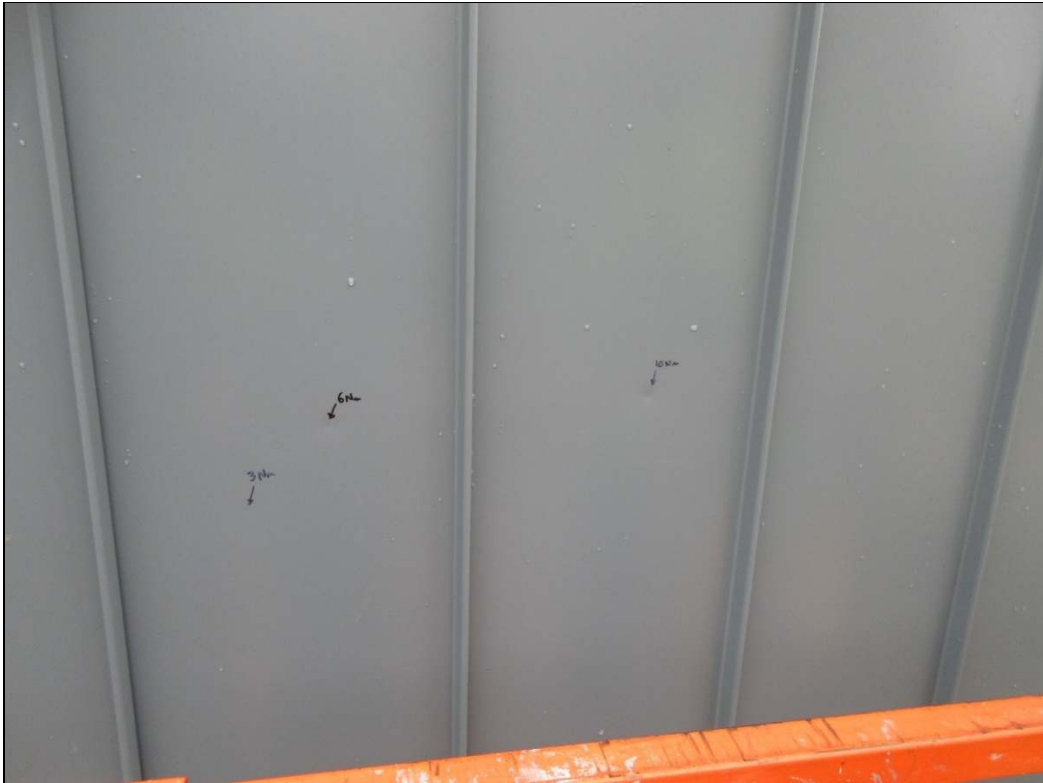
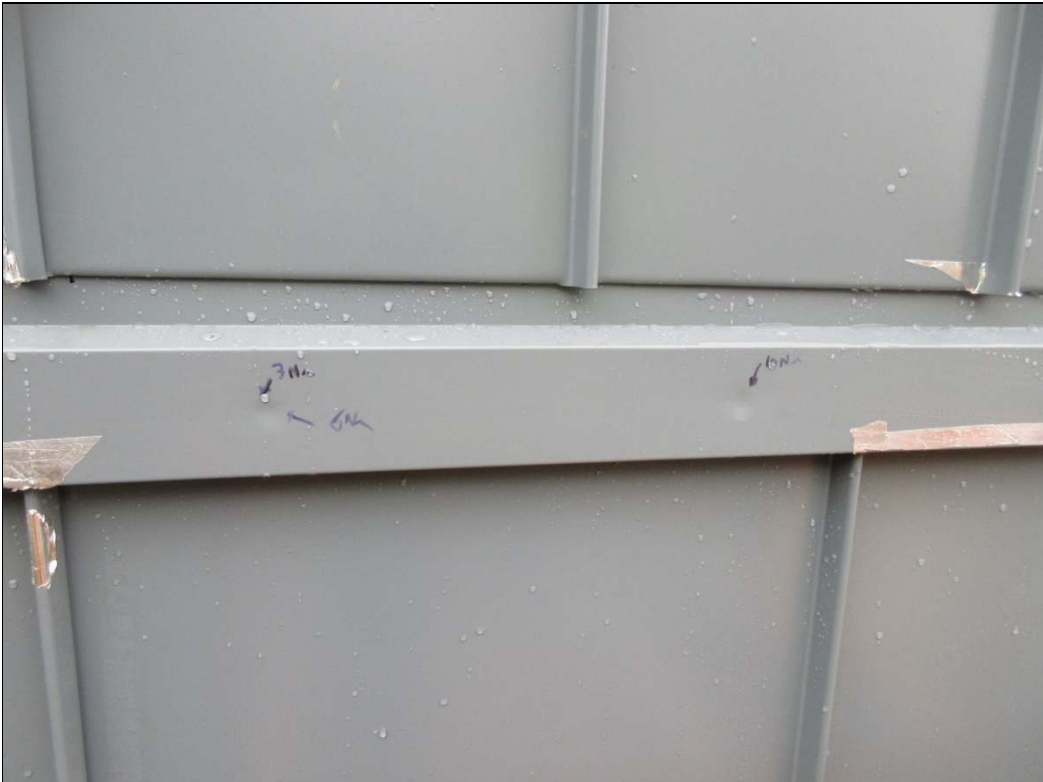
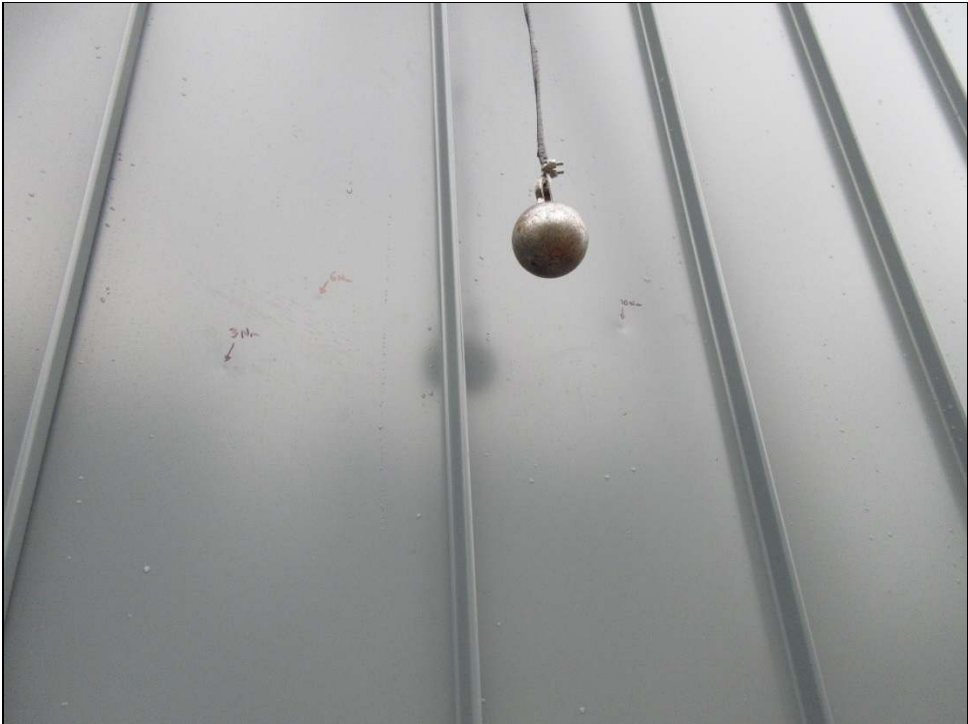
**HARD BODY IMPACT**

HARD BODY IMPACT
